Strategies to Prevent Rolling Contact Fatigue on Railroad Wheels & Rails

Harry Tournay
Sabri Cakdi

Presentation to SAE FD&E
May 6, 2015

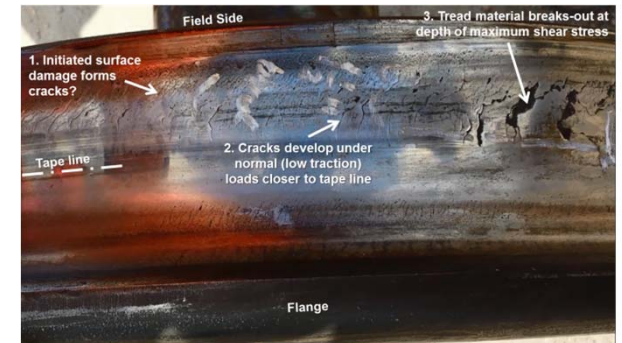
HIW due to high steering tractions

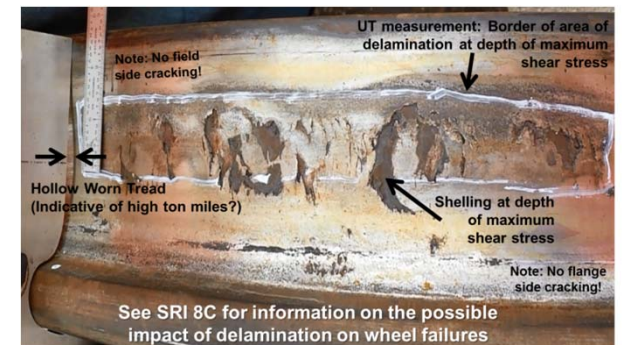
HIW due to shelling

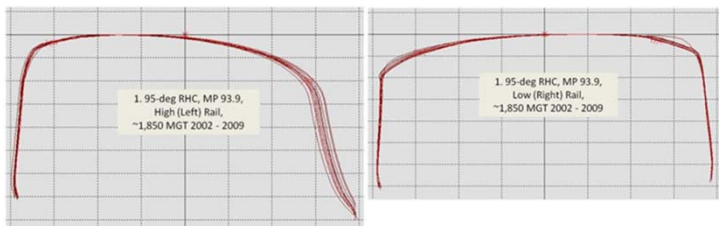
Rail Wear & Material Flow

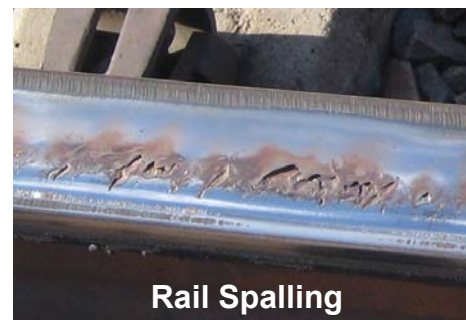
Rail Spalling

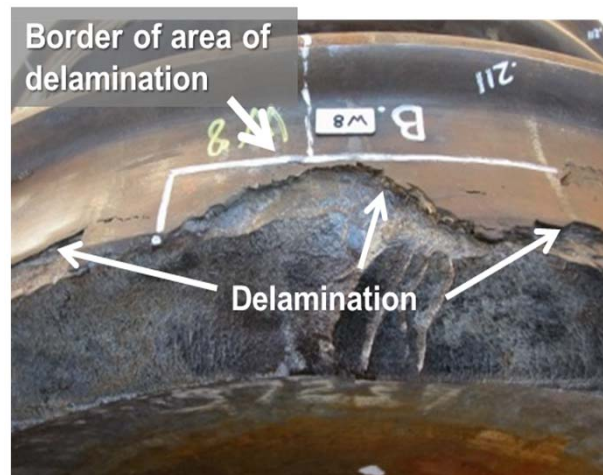
Vertical Split Rim

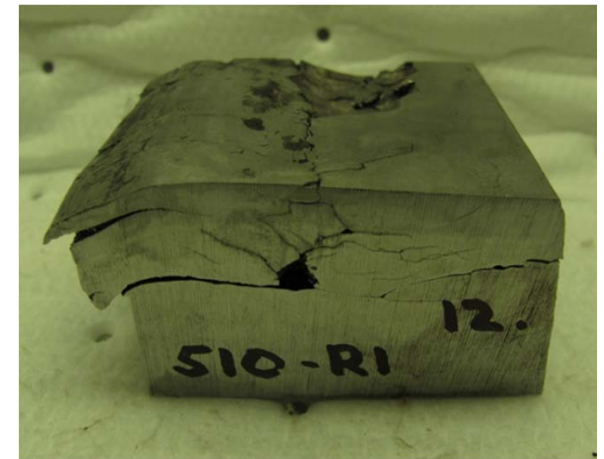
Shattered Rim

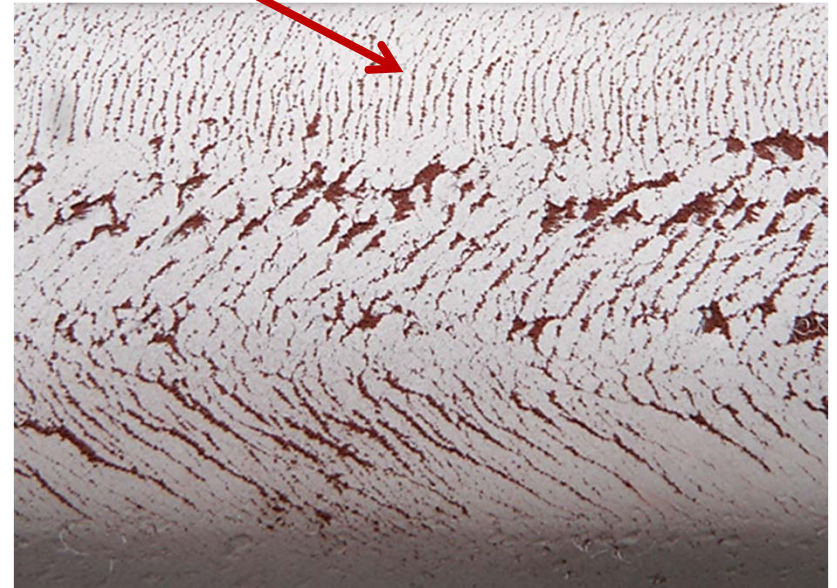
**Dye Penetrant Photograph of Rail
in Revenue Service**

Likely shelling at the depth of
the maximum
shear stress

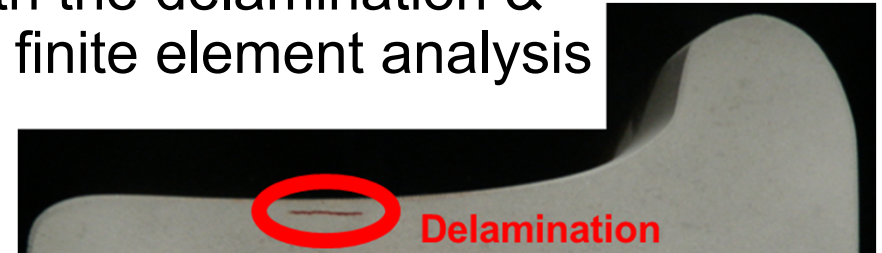
◆ Metallurgical analysis finds martensite along delamination interface

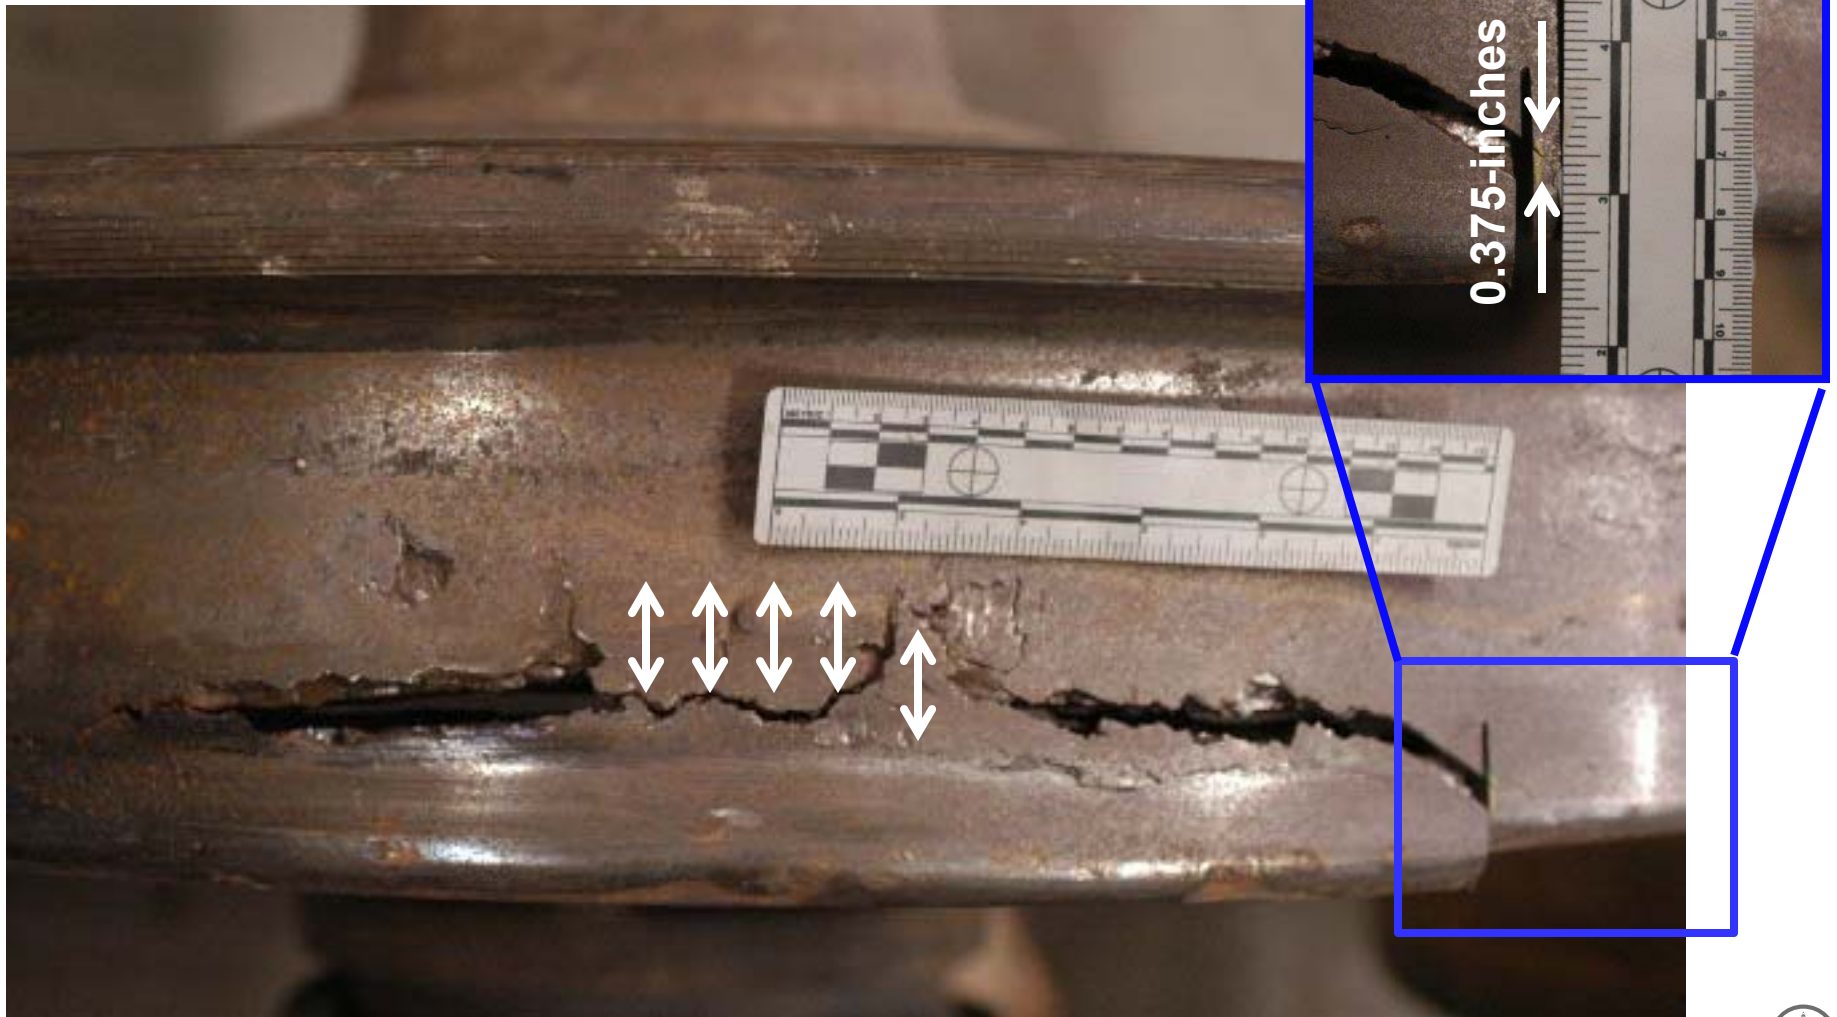
- ◆ **Evidence in support for the mechanism from partial VSR formation:** *(2008 BNSF study group report)*
