Impact of Columnar Grain Structure on Over-Stress Probe (OSP) Method for Fatigue Life Characterization in Aluminum Sand Castings

Dr. Robert Mackay, Dr. Anthony Lombardi, and Dr. Glenn Byczynski (Nemak)

2022 Society of Automotive Engineers - Fatigue, Design, and Evaluation (SAE FD&E)

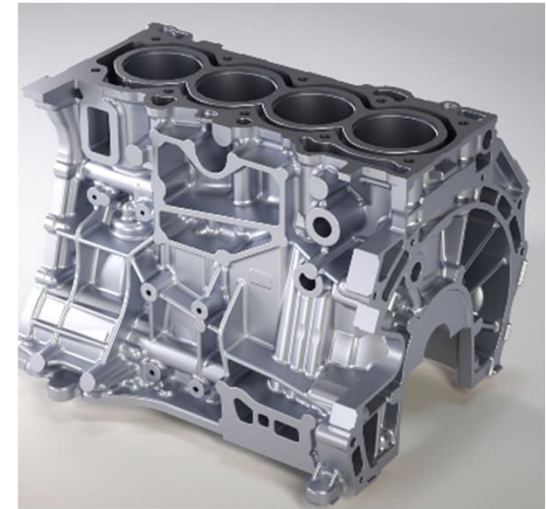
- The most common root cause of failure in mechanical structures is material fatigue. Fatigue is the process by which cracks develop and propagate to failure under cyclic loading.
- Due to the need for simplified & rapid testing, laboratory Life-to-Failure methods have been developed and allow for estimation of lifetime under representative service conditions.
- The Over-Stress Probe (OSP) method has been growing as an effective method to gauge fatigue durability of components.
- **Compliant** samples are defined as those that survive the target lifetime (10^7 cycles) at a defined alternating stress ($R = -1$).
- It will be shown for the OSP method fractography can be conducted on **compliant** and **non-compliant** test samples which in turn will assess the level of porosity/oxide (example shown to the right) damage and columnar zones.
