IOWA STATE UNIVERSITY

Fatigue Properties of Steel Castings and their Relation to NDE Results

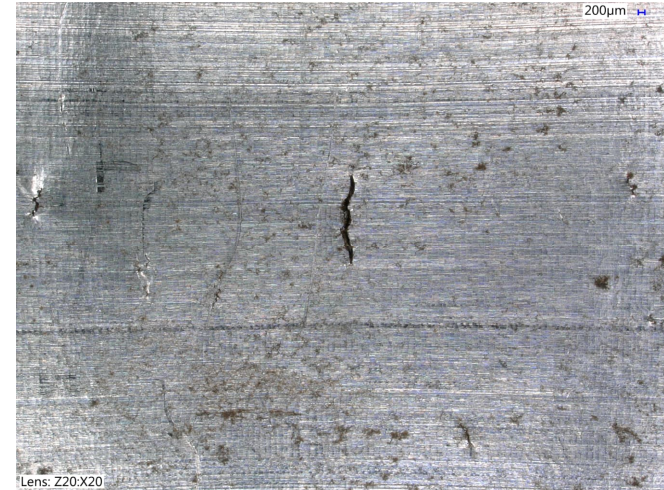
Machined surface opposite initiation side showing secondary crack

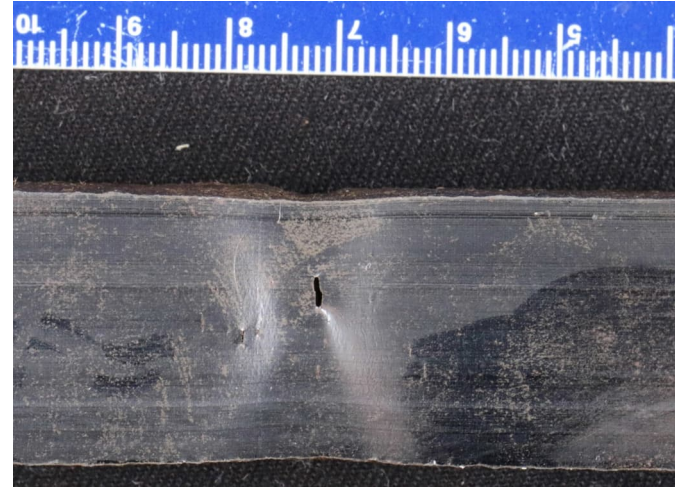
Machined surface opposite initiation side showing secondary crack

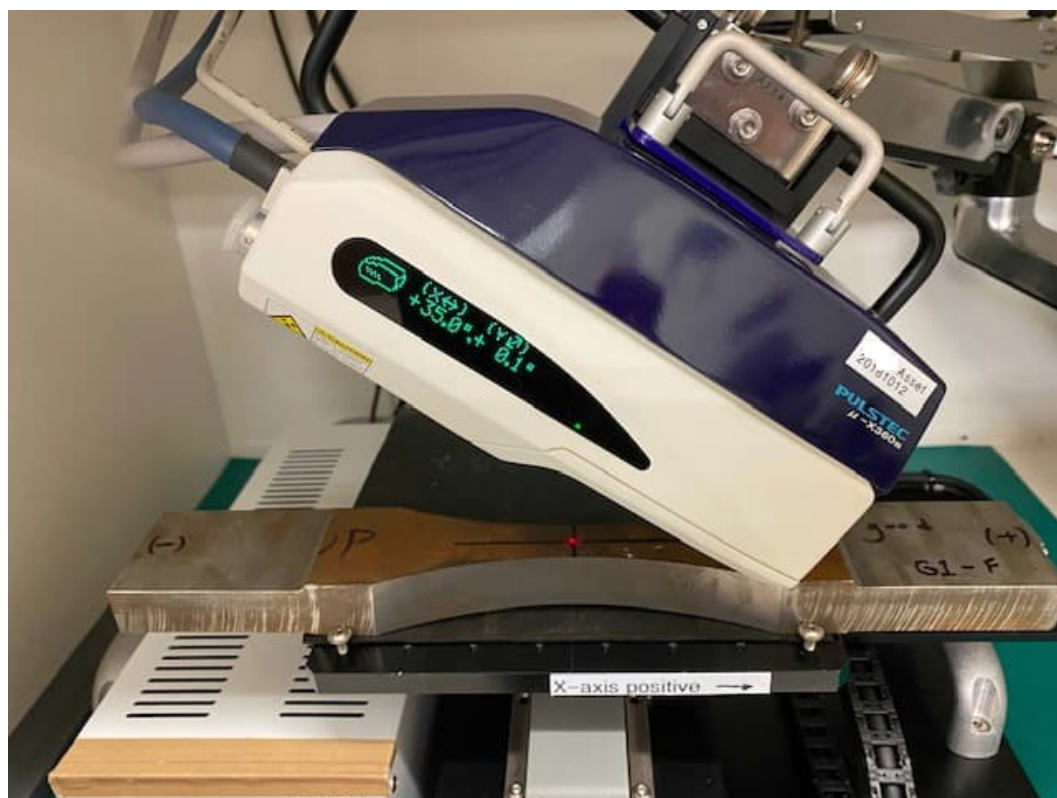
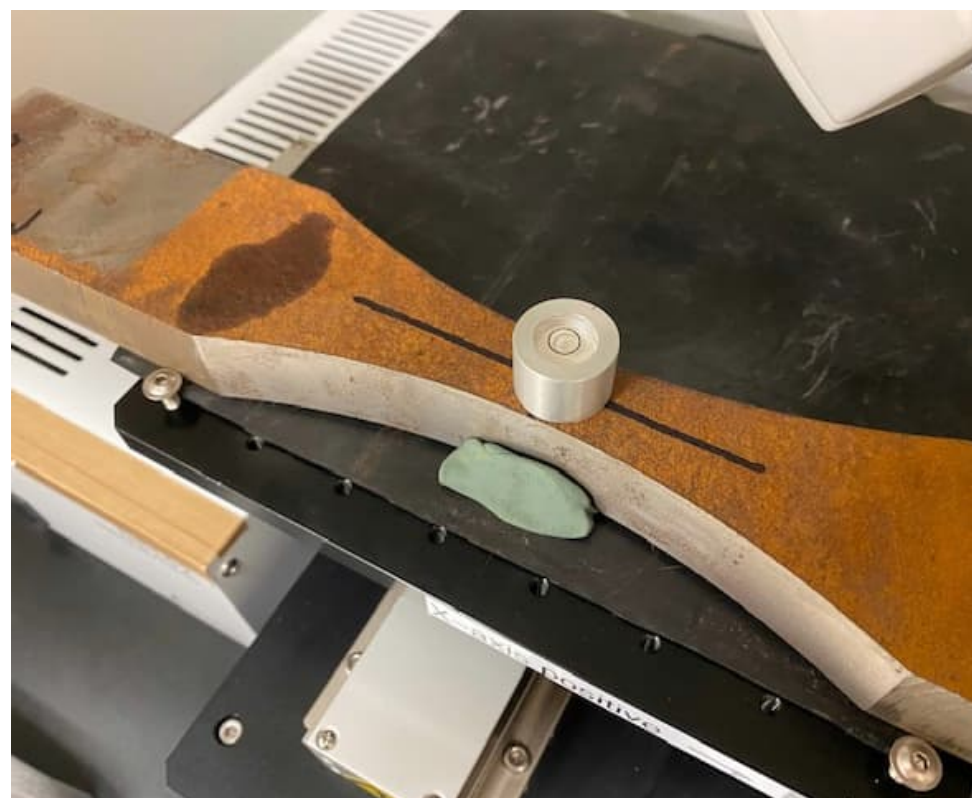
Pulstec μ -360s x-ray diffractometer (chromium tube)
Cosine α approach with area detector*
Sample surface is held horizontal so that incident angle of x-ray beam is controlled
X-Y positioning table is used to collect area scans or line scans
